CAUTIONARY NOTES

Conditions That May Adversely Affect TC-417 Installed on Metal Substrates

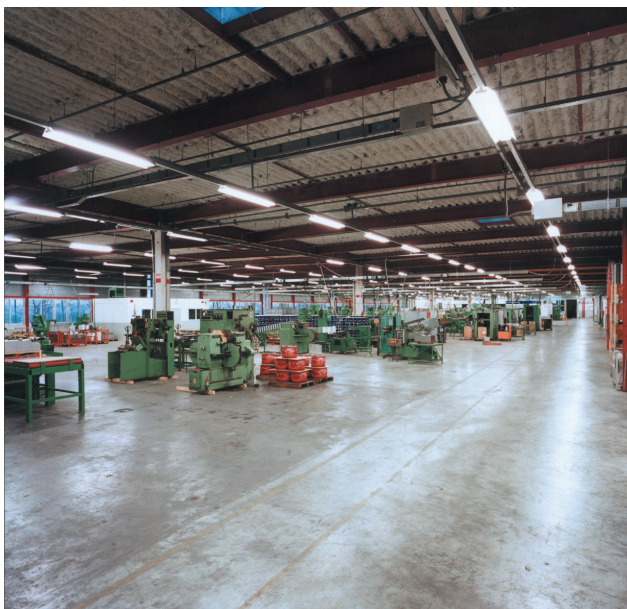
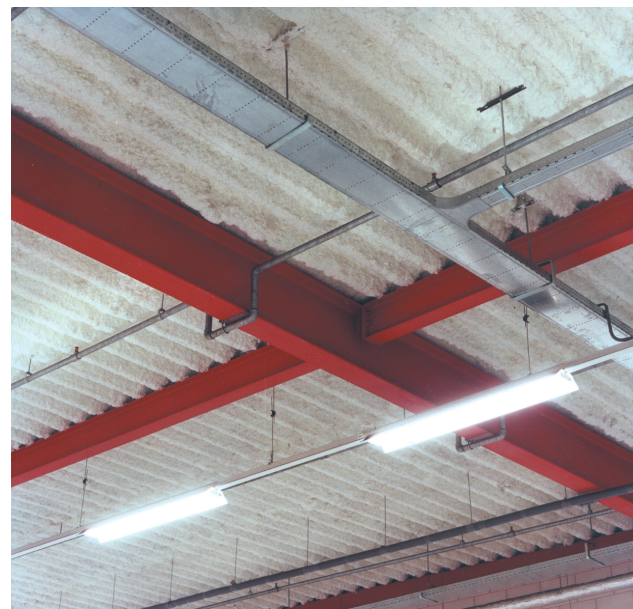
7. Structurally Sound Steel Decking

The following two pictures illustrate an excellent thermal/acoustic installation on structurally sound steel decking.
